Inspection Report

Minerals Regulatory Program

Mine Name: Papoose
Operator Name: Cotter Corporation

Permit number: M/037/084
Inspection Date: October 5,
2005
Time: 2:15-2:40

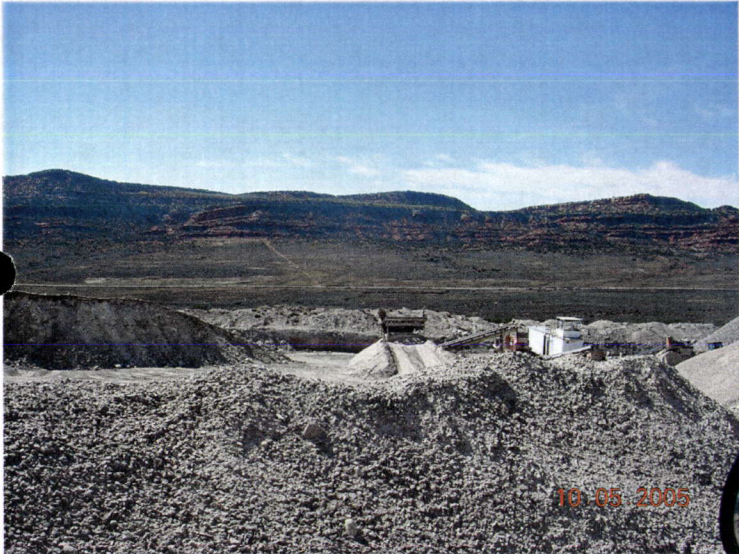
The mine plan says the operator will do concurrent reclamation as much as possible, but so far, the operator has not been able to do any final reclamation. We discussed this with Mr. Showalter who said that because of the long, narrow nature of the mine layout, and because of the product stockpiles, it has not been possible to reclaim any of the area.

Photo 1. Some of the product stockpiles.

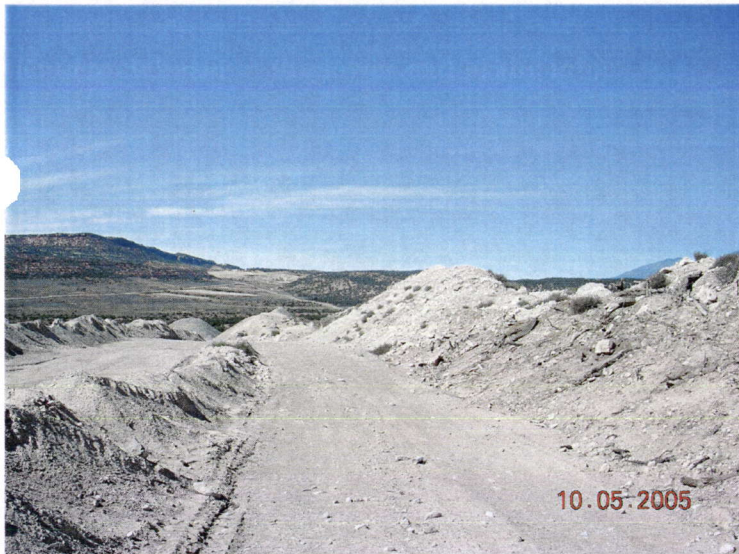
The mine is on a limestone ridge with mostly very shallow soils, but the operator recently mined through a small drainage and was able to recover much deeper soils which were stockpiled along the road running northeast of the mine.

Photo 2. The road along the northeast side of the mine. The operator stockpiles soil next to this road.

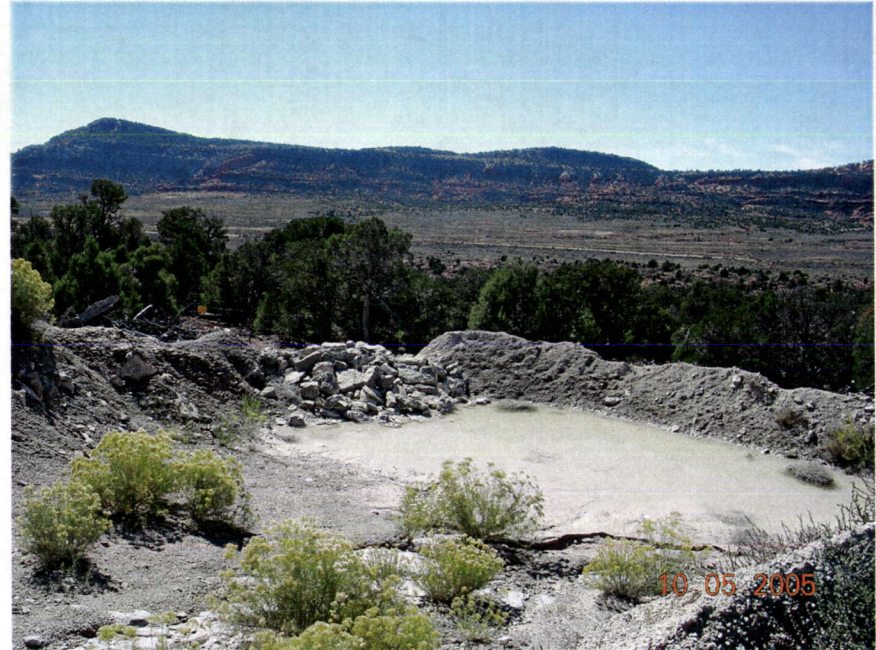
There had been some recent heavy rain, but it appeared the sediment control was working properly (Photo 3). The outlet of the sediment catch basin is essentially a rock filter which makes it less likely to fail.

Photo 3. Sediment catch basin at the lower end of the mine.
